**MarkWest Houston Gas Plant  
Inspection Report  
Chartiers, Pennsylvania**

Region III Office of Air Enforcement & Compliance Assistance  
Inspection Date: April 28-30, 2015

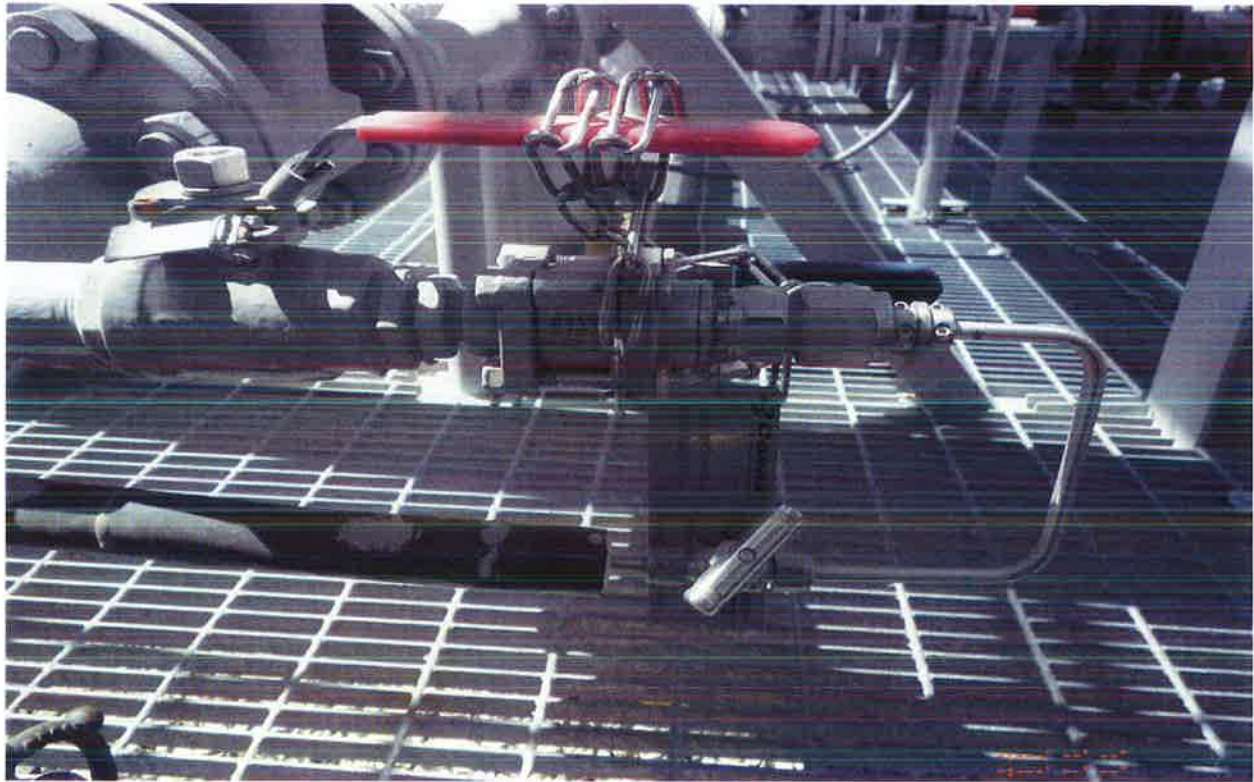
7. Closer view of untagged valves at De-propanizer 4 skid – MarkWest Houston – 04/28/2015

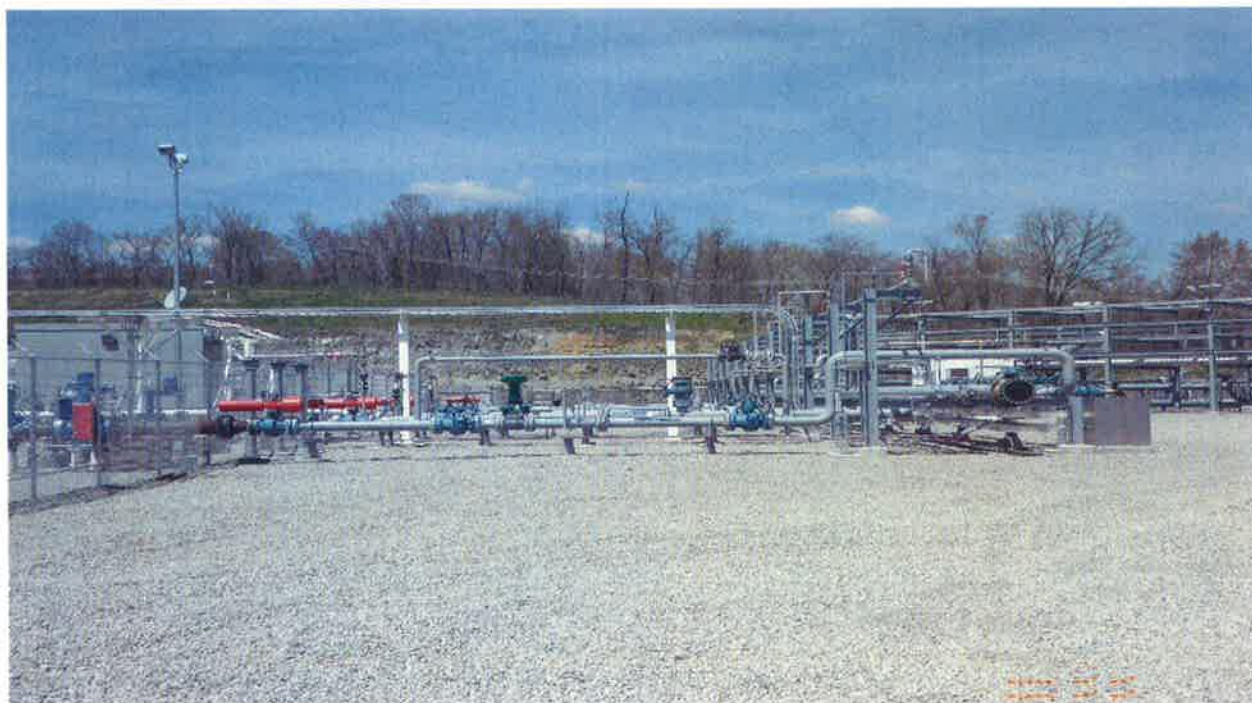
- The Mariner East Pipeline<sup>6</sup> runs adjacent to the facility and there is a tie-in on MarkWest property. There are no LDAR tags on this line.
- There are sporadic tags in the propane refrigeration building with some lines being tagged partially while the remainder of the line isn't tagged.
- EPA observed several hundred LDAR tags on lines downstream of the De-ethanizers which should not be included in the LDAR system.
- At least five valves were observed on insulated lines with no access port for LDAR monitoring.
- There were no LDAR tags on any equipment located in Storage Pad 3. There are nine bullet tanks in this area.

14. Mariner East Propane Pipeline Untagged for LDAR – MarkWest Houston – 04/29/2015

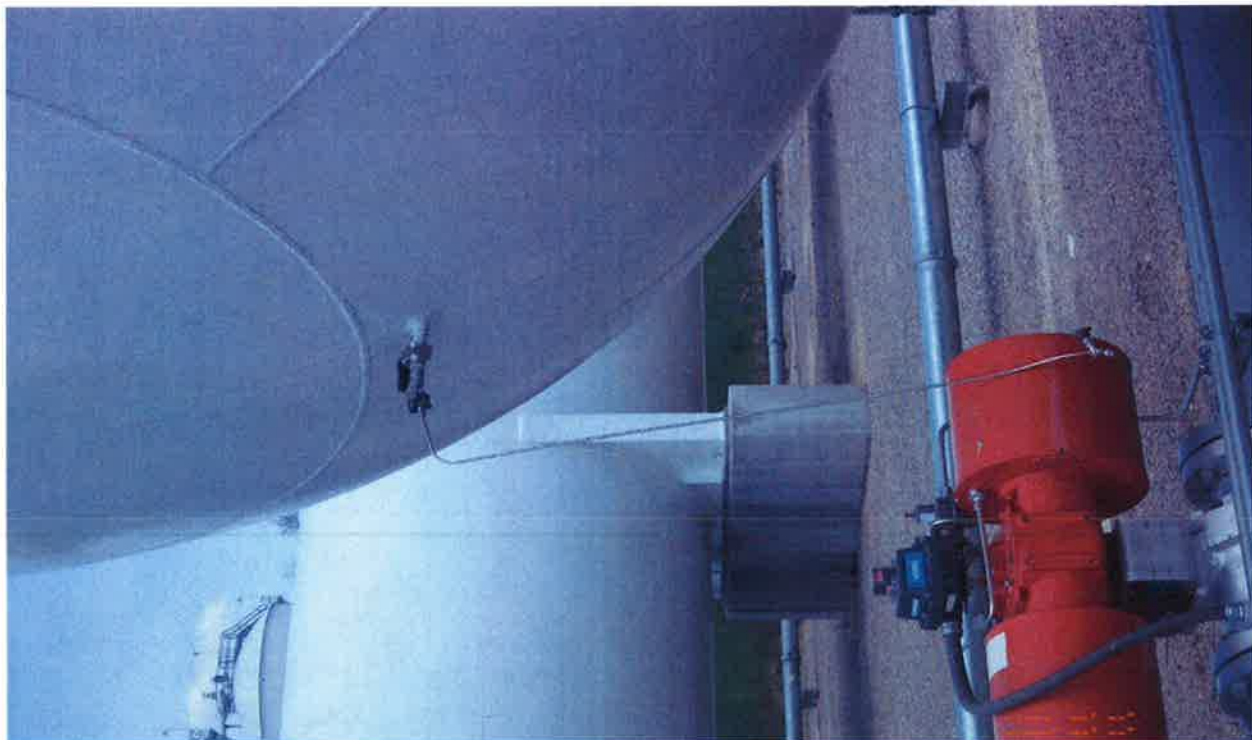
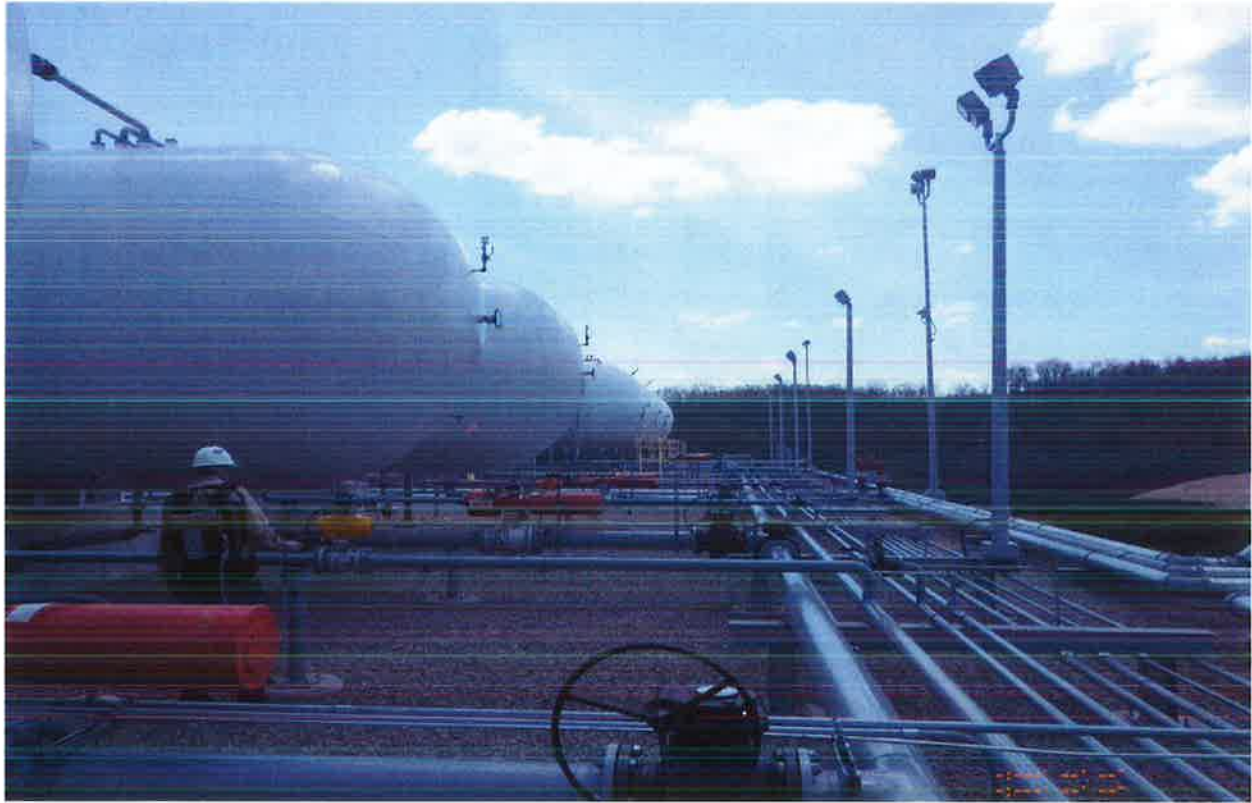
15. Pad 3 N-Butane Storage Bullets – MarkWest Houston – 04/29/2015

16. Second View of N-Butane Storage Tanks – MarkWest Houston – 04/29/2015

17. Sampling Line from N-Butane Storage Tank – MarkWest Houston – 04/29/2015

18. N-Butane Storage Tank – MarkWest Houston – 04/29/2015

19. N-Butane Storage Area Untagged for LDAR – MarkWest Houston – 04/29/2015

6. There were no LDAR tags and all of the components in the Storage Pad 3 (Nine n-butane storage tanks) were not included in the LDAR program. Mark West commenced identifying and tagging this area while the inspection was ongoing. After the inspection MarkWest stated that 281 valves, 660 connectors, and 18 process safety valves were tagged in this area.

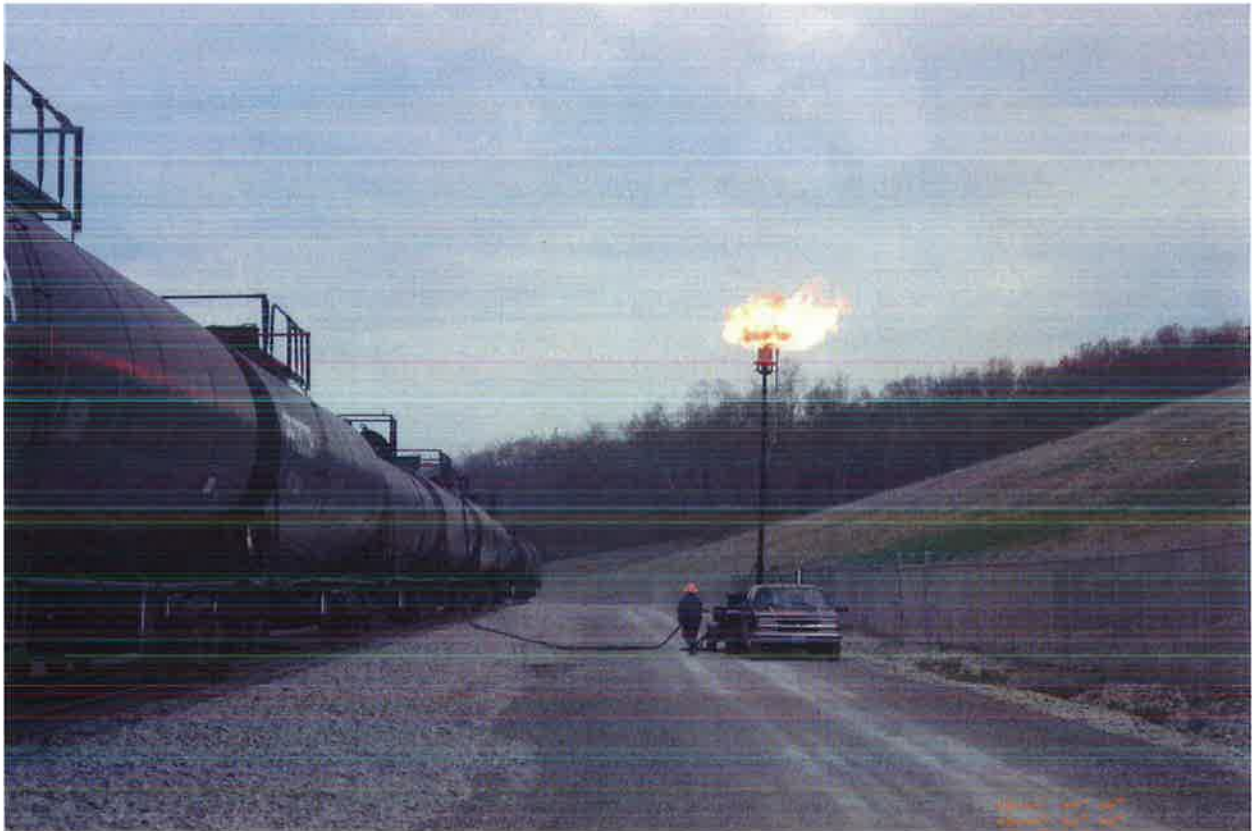
27. Temporary Flare Venting Railcar – MarkWest Houston – 04/30/2015
